EXISTING CONDITIONS REPORT

BETHESDA EPISCOPAL CHURCH

SARATOGA SPRINGS, NEW YORK

MARCH 2016

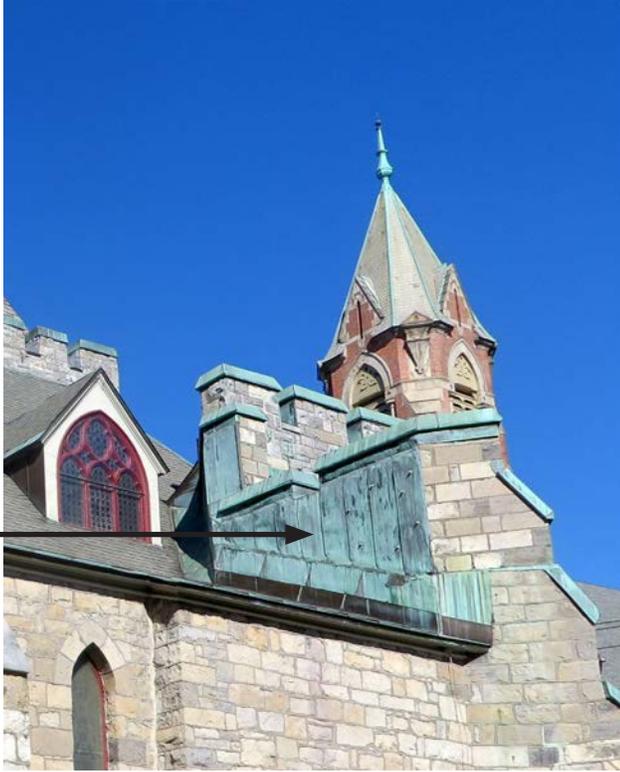
**EXCESSIVE
FLASHING**

The asphalt shingle roofing is nearing the end of its life and is out of character with the historic architecture of the church. In many areas, excessive and unnecessary flashings obscure the masonry walls.

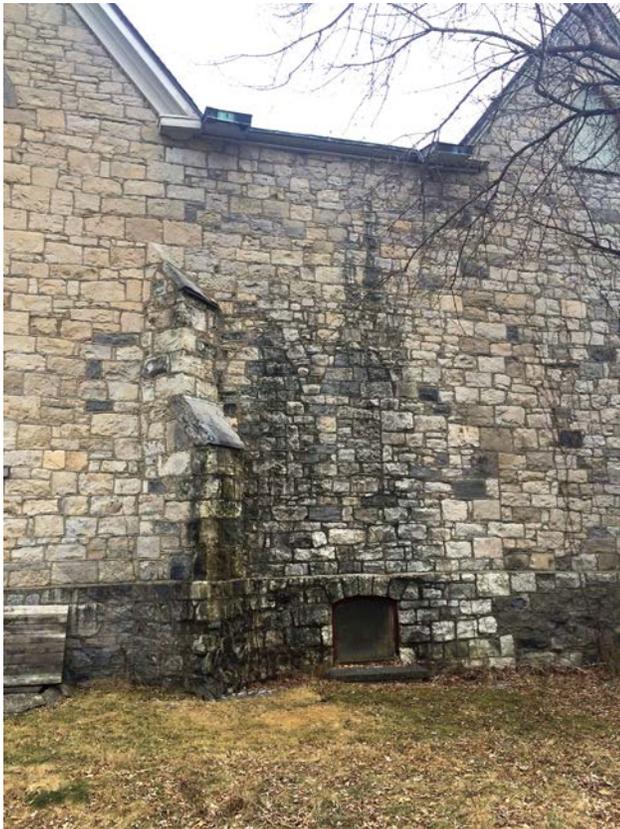
There is deterioration of the cornice below the sheet metal overflows on the west elevation. The masonry walls near the south buttress show signs of excessive moisture caused by the roof drainage above the buttress.

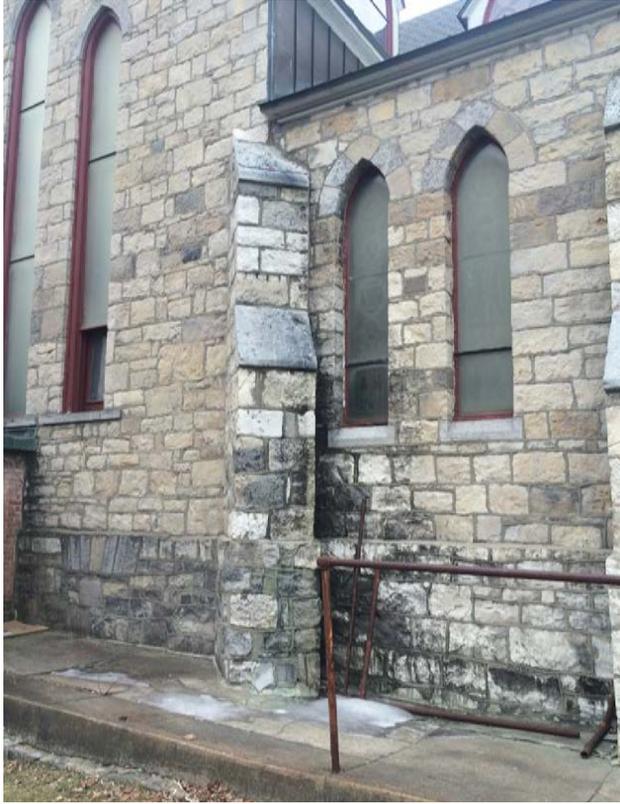
The walls have unwanted moisture and there is decay at the cornice near the south buttress on the east elevation. This deterioration is caused by poor roof drainage.

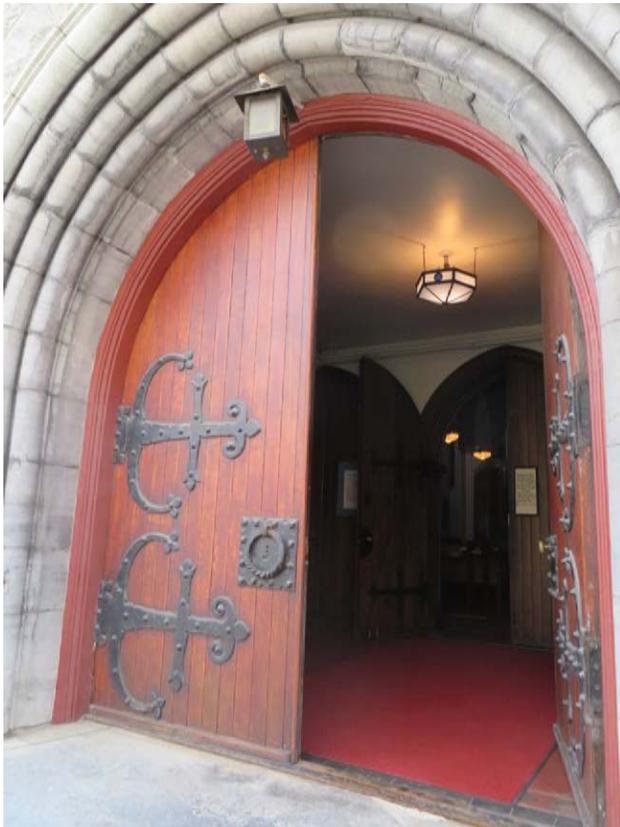
The door threshold at the front entry door on Washington Street is heaved. Both the threshold, historic hardware and light fixture above the door are rusted and the door requires weatherstripping.

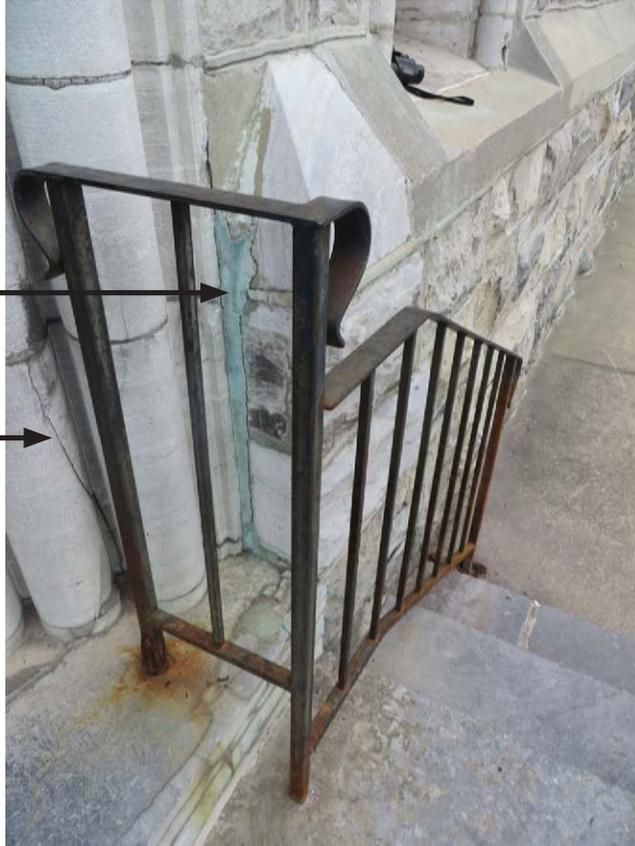
(Left) The entry railing is rusted and has caused staining on the stone stair. The handrail is currently unanchored and loose. It is a safety hazard. Behind the railing, on the masonry wall, is evidence of a failed caulk repair. Stone cracking, caused by minor stone movement, is evident at the door surround.

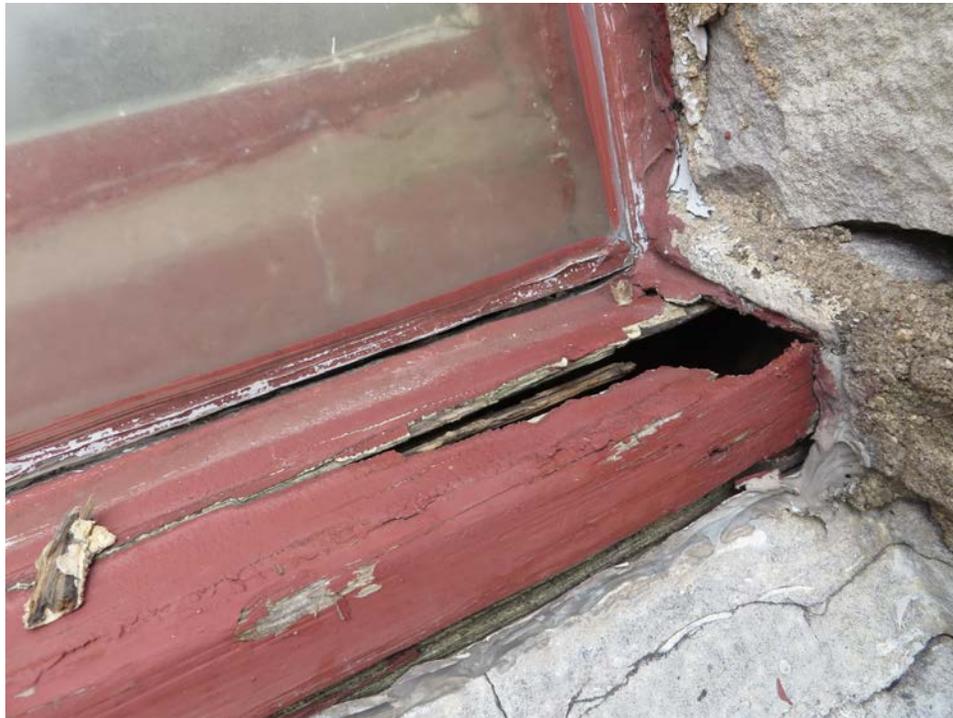
(Below) There are signs of decay at numerous failed window frames, including the large stained glass window in the chancel.

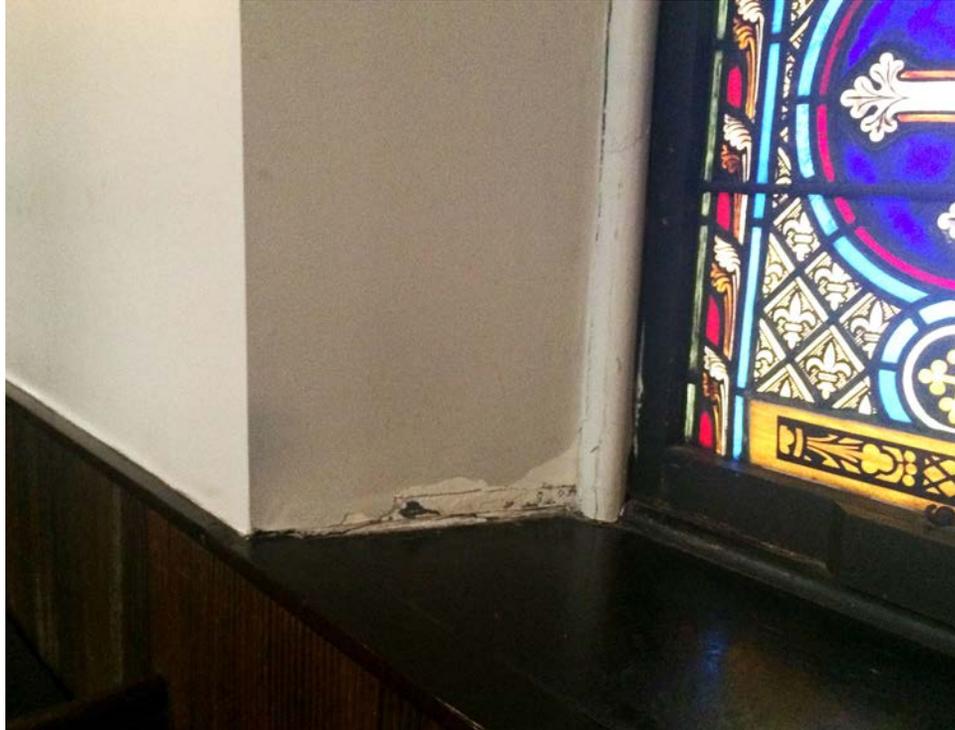
(Above) Some degree of air or water infiltration occurs at most windows. Because wood window sills are often sloped inadequately to drain water away from the building, water pools on the exterior and travels inward to damage interior window plaster.

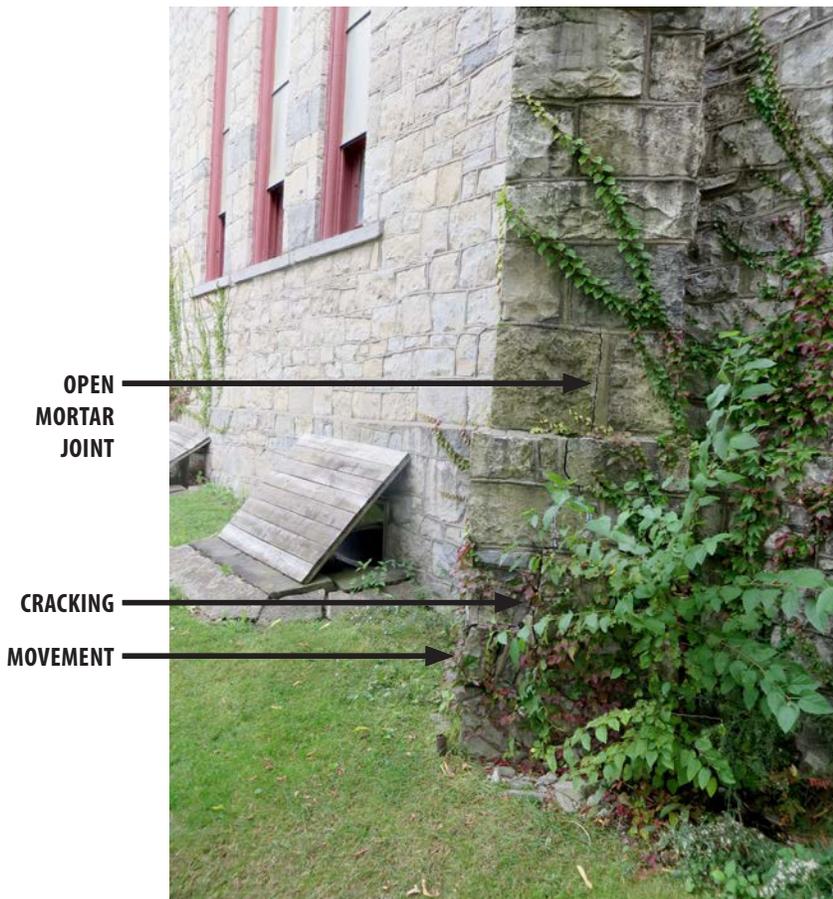
(Left) The lower south buttress, on the west elevation, shows signs of stone movement, open mortar joints, and cracking that is caused by settlement of the masonry.

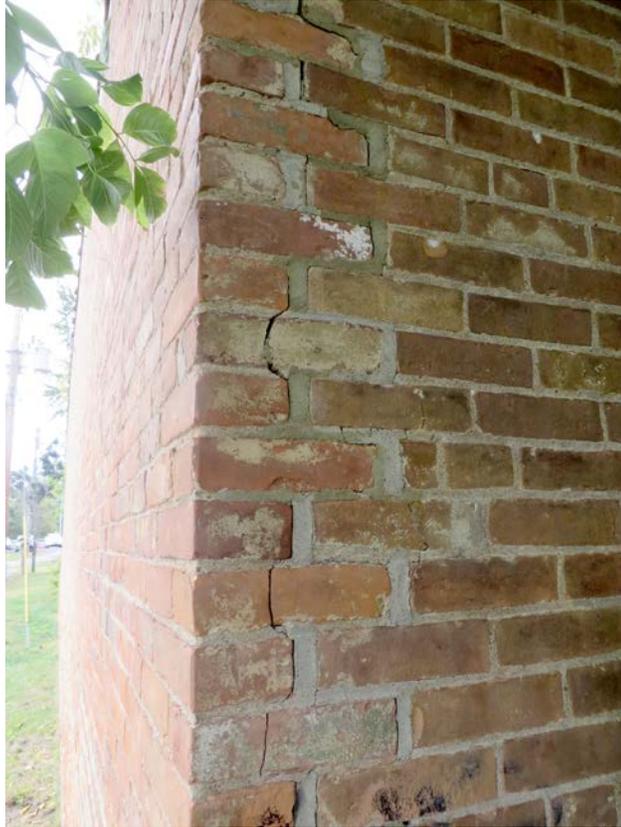
Step cracking exists at the exterior southeast corner of the brick courtyard. The step cracking is the result of minor settlement along with recent repointing with hard, portland cement mortar that is not compatible with the historic masonry. The step cracking should continue to be monitored for evidence of continued movement.

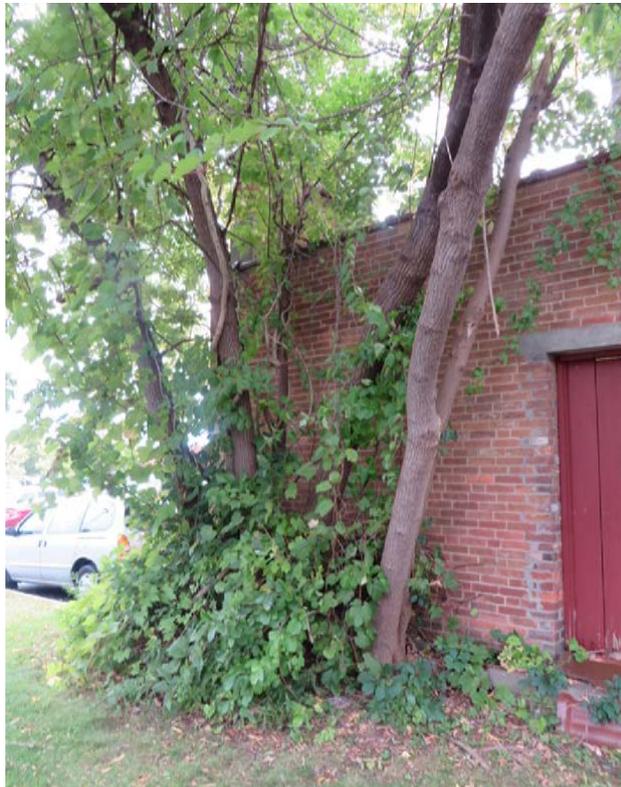
Weed trees grow near the courtyard walls. The root systems of the trees, if left in place, could damage the courtyard footings and foundations.

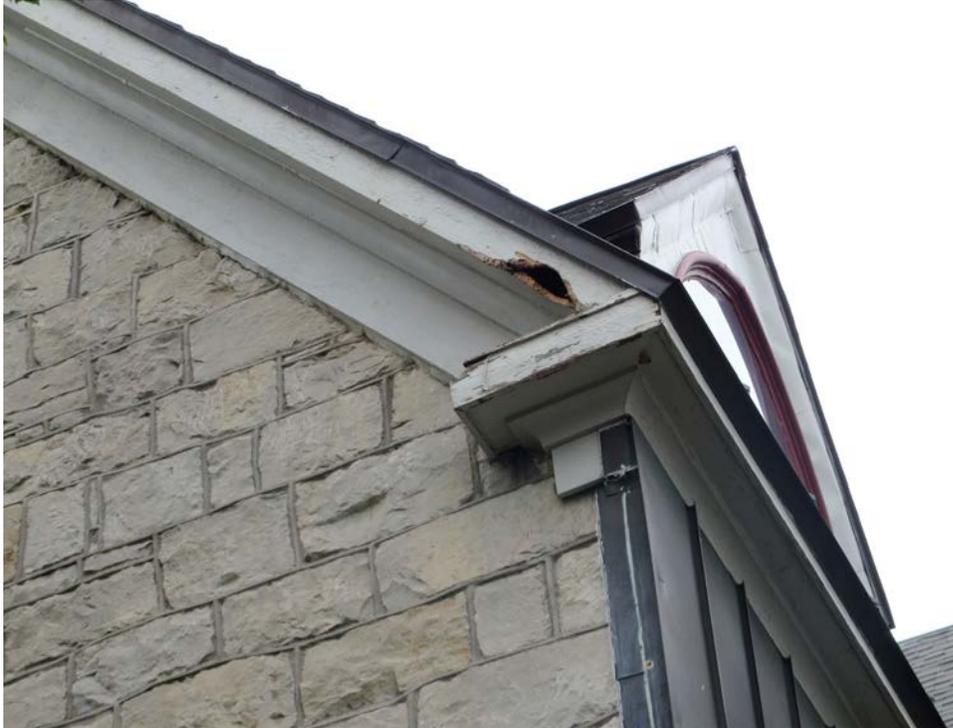
(Above) There is squirrel damage on the east elevation at the transept cornice.

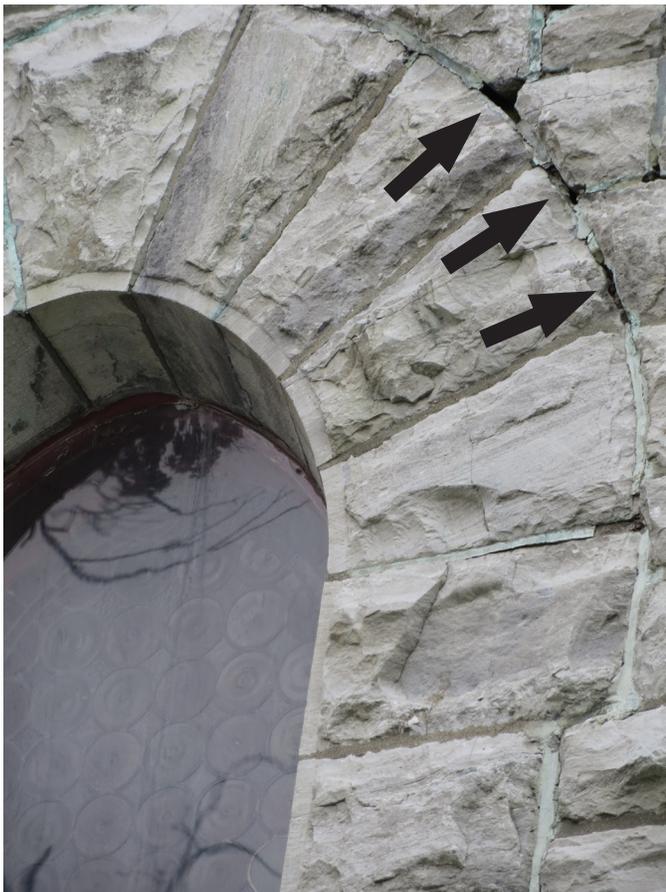
(Left) Open mortar joints above the arched windows of the tower on the west elevation could be a source of water infiltration.

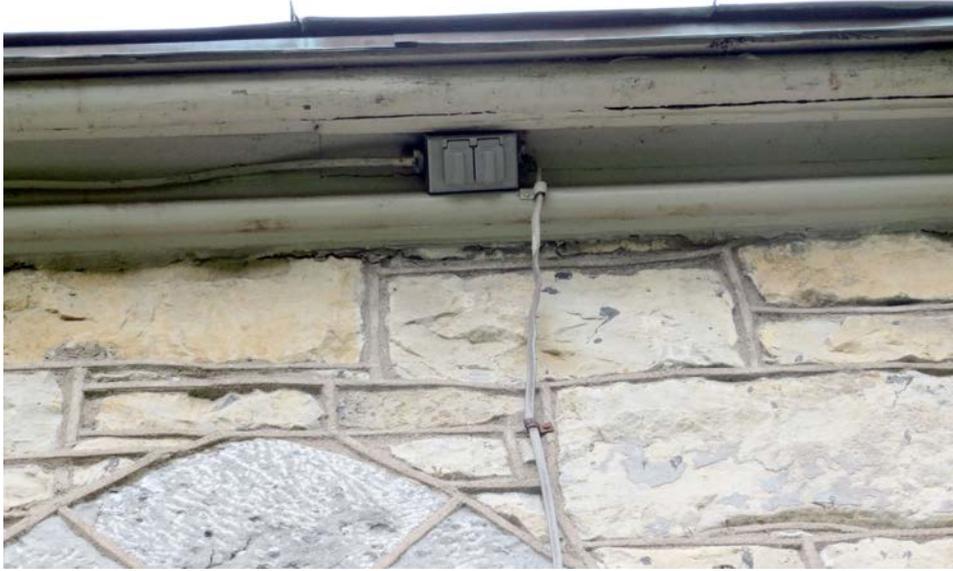
There are electrical outlet boxes and exposed wiring on the wood cornice.

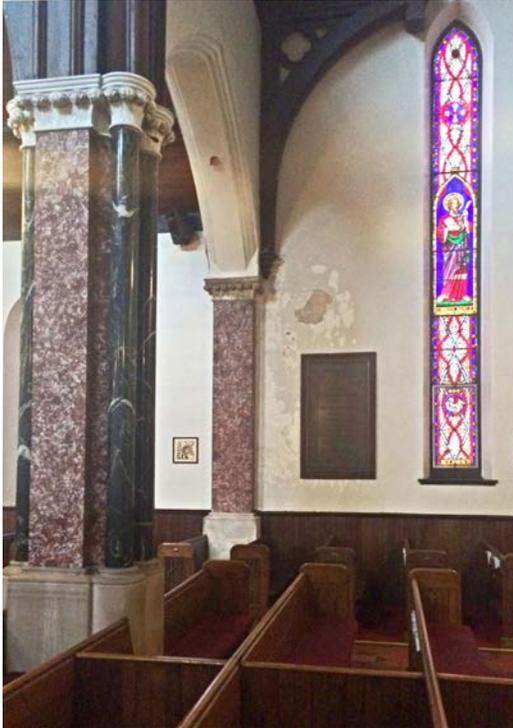
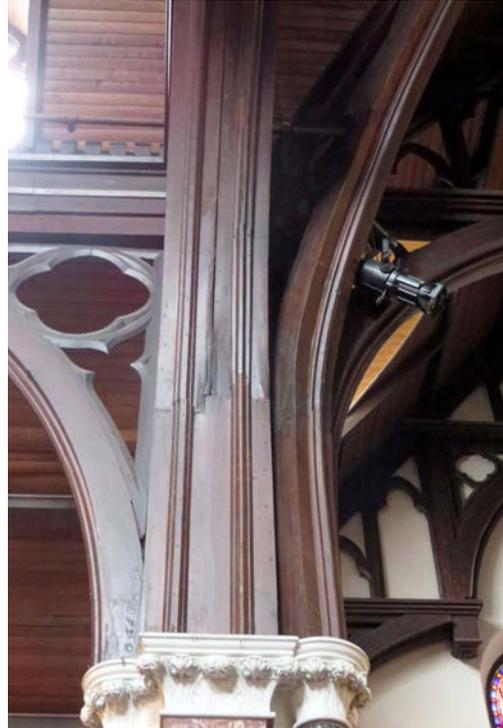
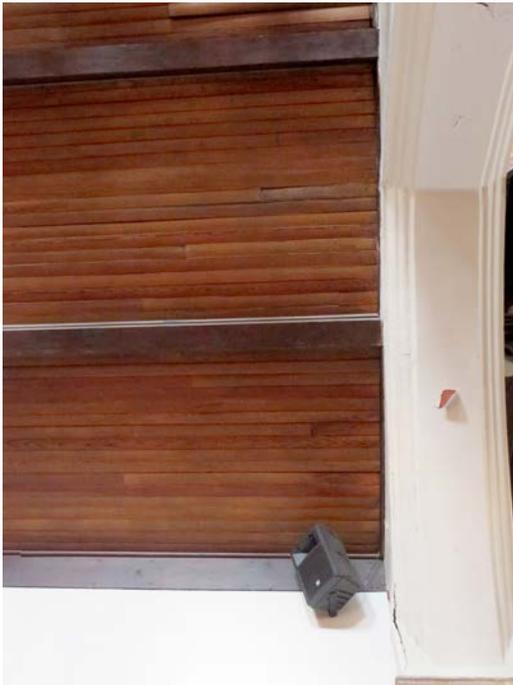
Previous roof leaks, open masonry joints, and deteriorated flashings have resulted in staining and plaster damage at each transept. There is also evidence of decay at the underside of the wood hammer beam trusses and at the beaded board ceiling in the side aisles.

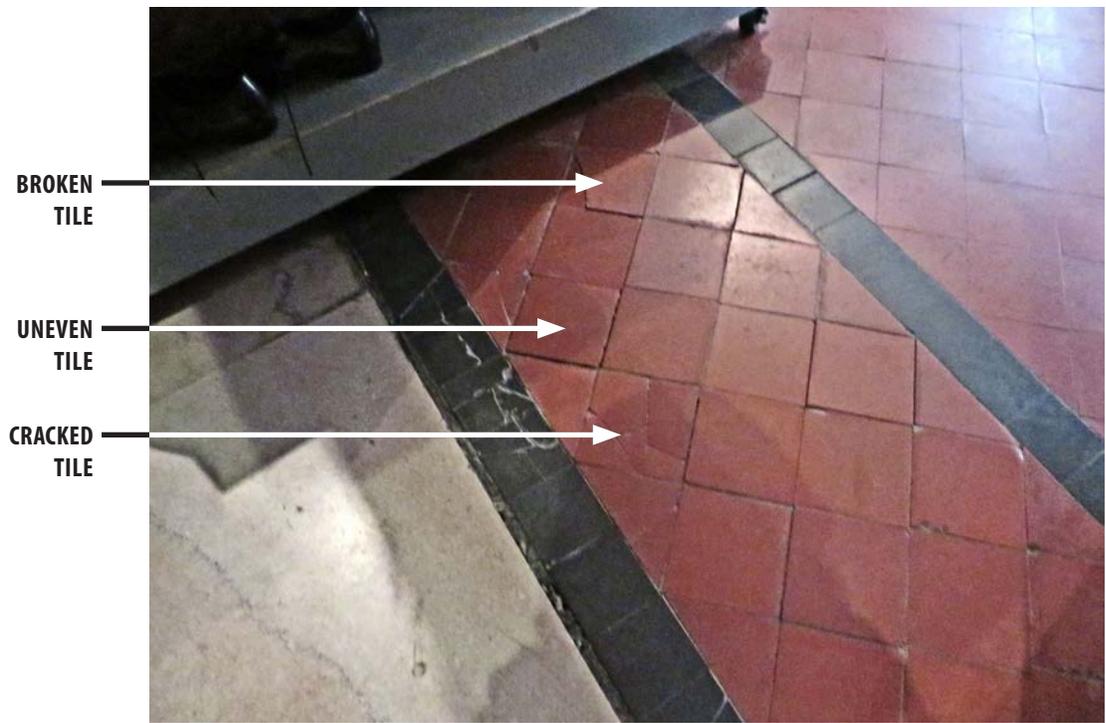
Various areas in the church have cracked, broken, or misaligned historic ceramic floor tiles.

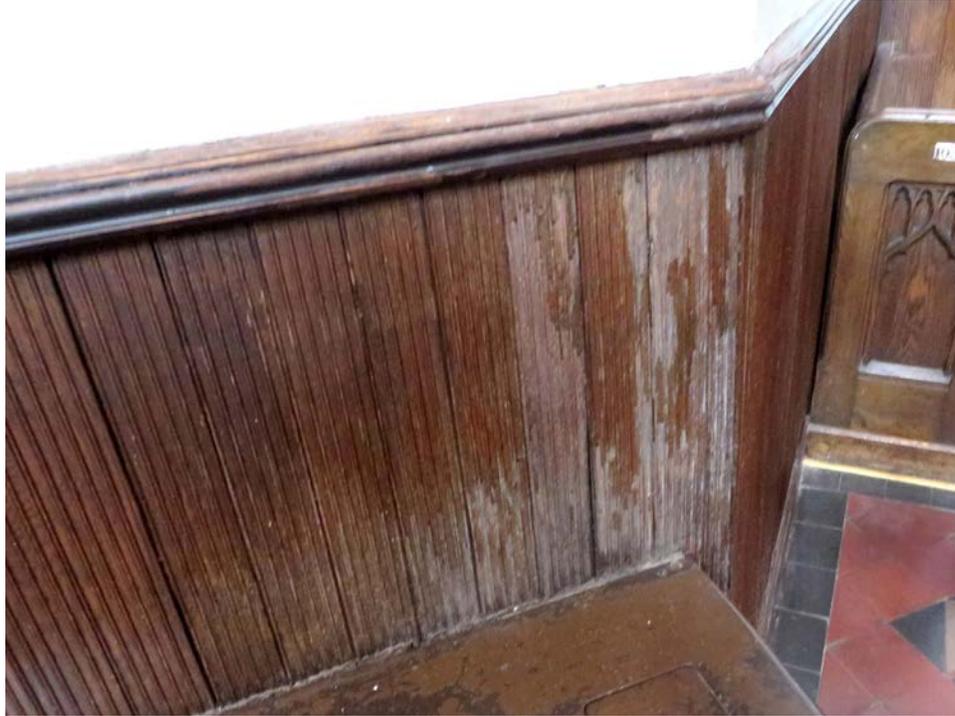
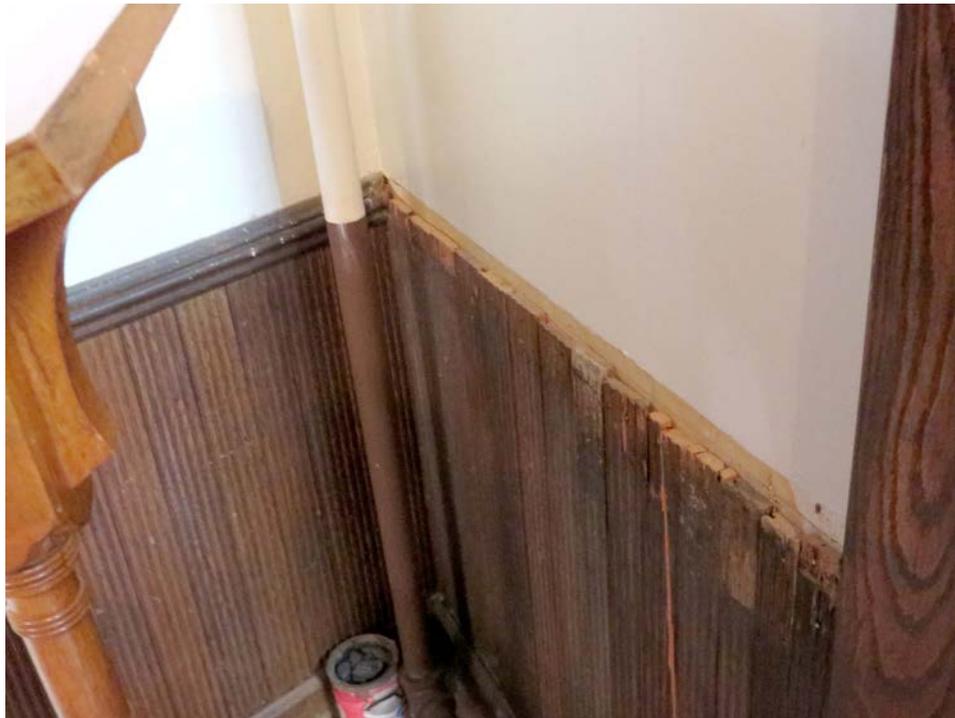
The wainscot above the radiators is damaged and warped throughout the building. The wainscot is loose, and the wainscot cap is missing in numerous locations.

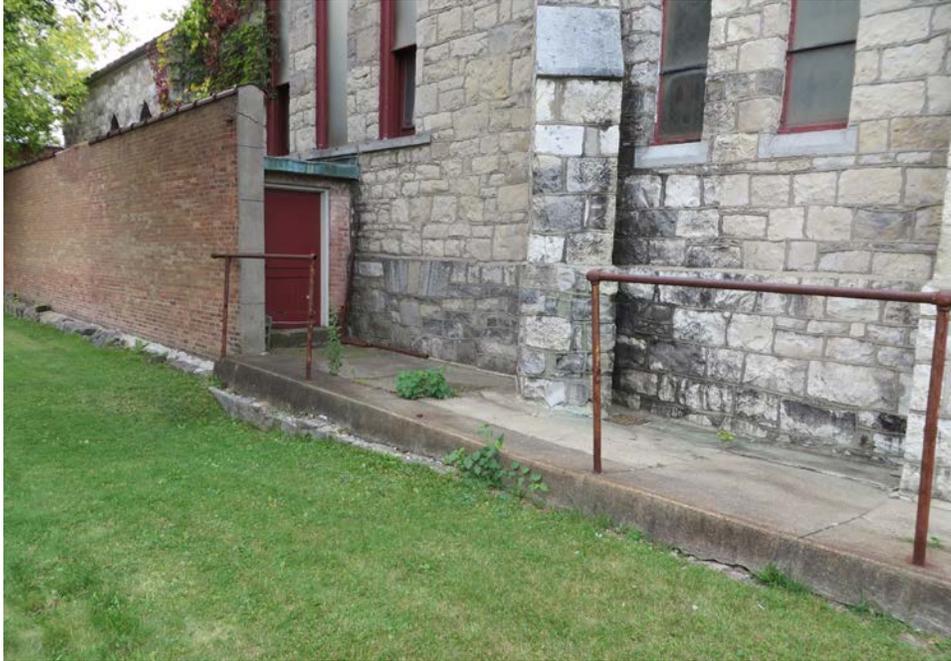
(Above) The sidewalk at the east side of the church is heaved and cracked with many tripping hazards. It is sloped towards the building in some places. There are extensive moisture issues in the undercroft and the sidewalk is located where future stormwater drainage needs to be installed. ***If funding permits, Phase I construction will include this work.***

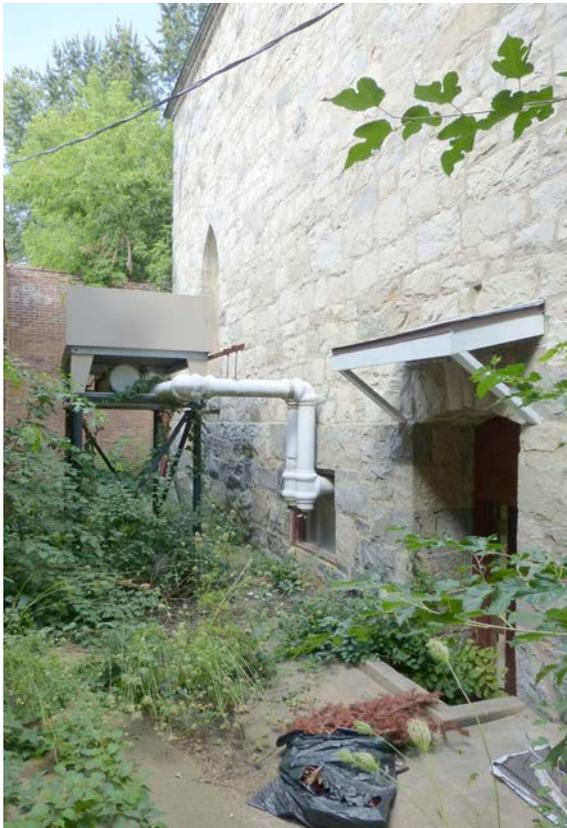
(Left) The concrete sidewalks inside the rear courtyard should be removed and the concrete stair in the courtyard replaced with a stair that is code compliant. A perimeter drainage system and waterproofing need to be installed around the foundation of the building to prevent water infiltration. ***If funding permits, Phase I construction will include this work.***

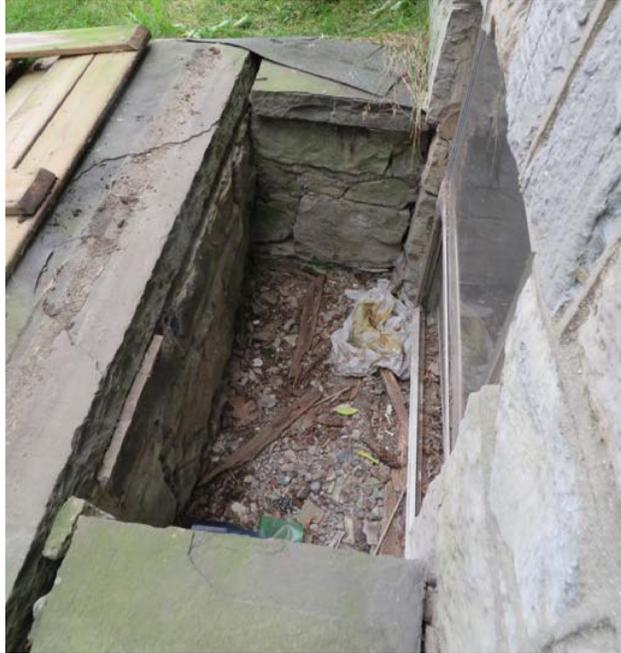
The existing basement windows wells show signs of stone movement, joint failure and improper drainage. They need to be replaced. At the existing window wells there is significant moisture infiltration into the undercroft. ***Phase I construction includes rebuilding the exterior light wells and installing new storm water drainage.***

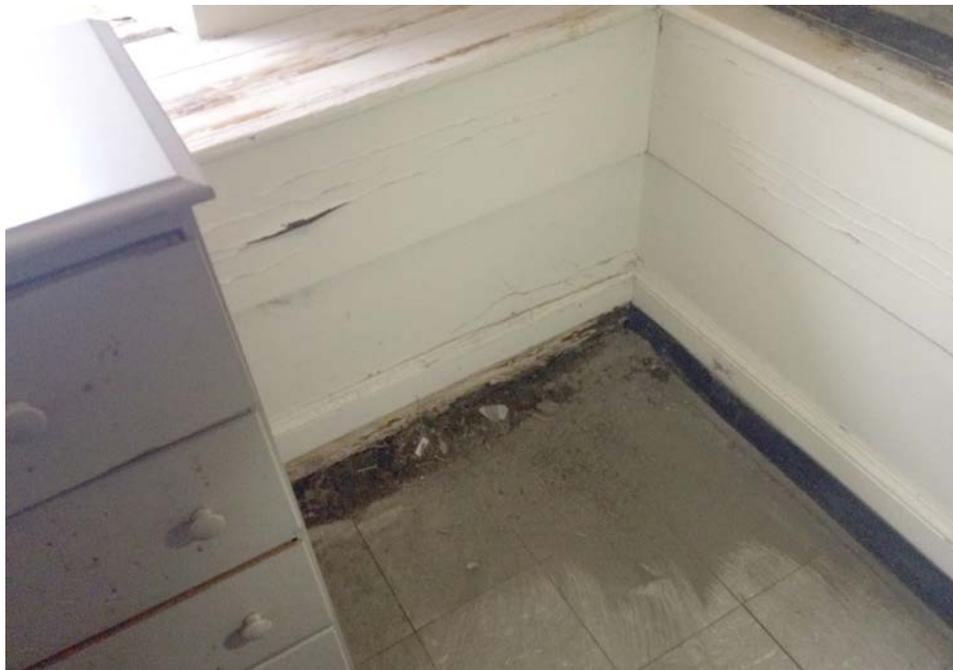
In the undercroft along the perimeter of the building, there are numerous signs of water infiltration from the exterior light wells. The leaking at this light well has caused the baseboard to decay. ***Phase I construction includes rebuilding the exterior light wells and installing new storm water drainage.***

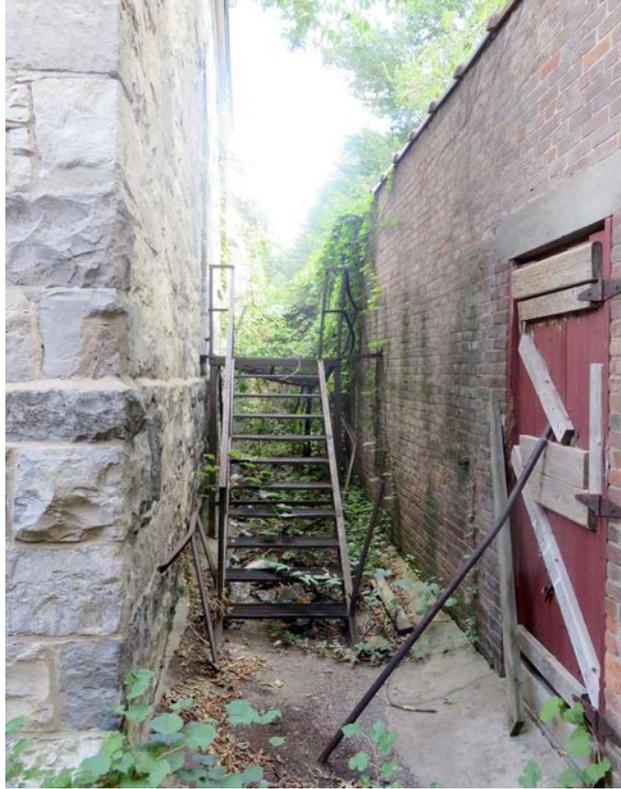
The existing fire stair in the rear courtyard is a safety concern because of its general state of disrepair. *This stair is scheduled to be replaced in Phase I construction. Alterations will also be made to the Sacristy door that is at the top of the stair. The swing of this door will be reversed and hardware added to make the door code compliant.*

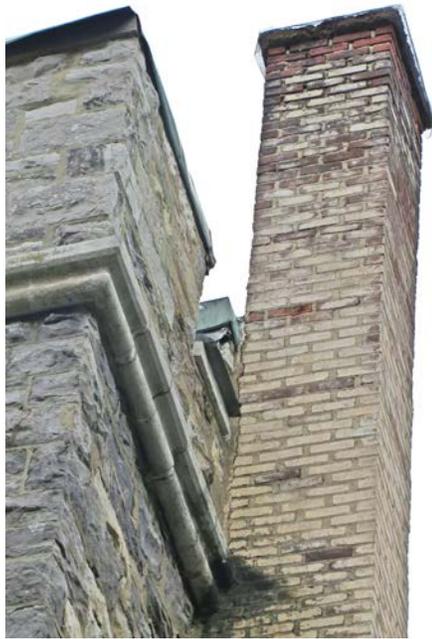
The upper brick courses on the north chimney are shifting and have open mortar joints. *In Phase I construction a new mechanical room will be constructed in the addition. Space will be reserved for a new boiler for the existing church. After the new boiler is installed, this chimney will no longer be used and it can be demolished.*

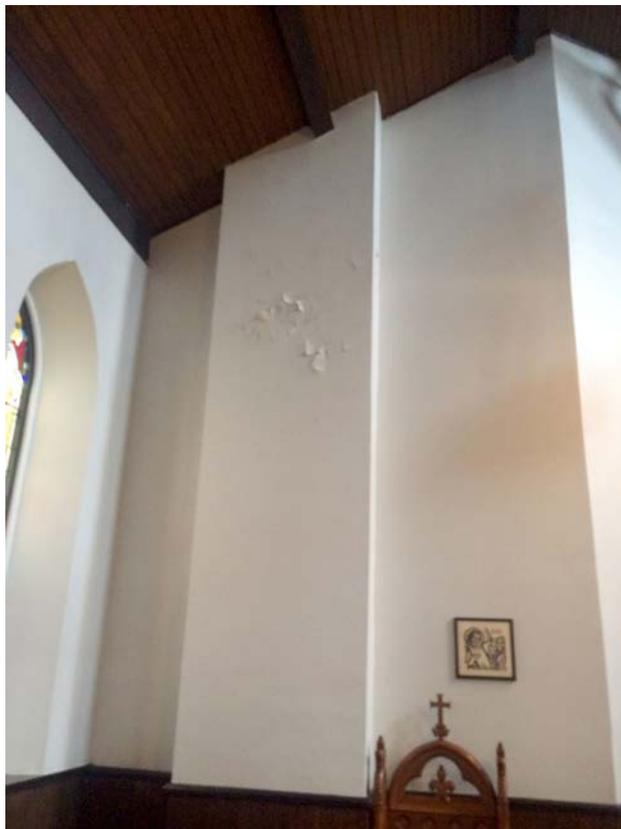
On the interior of the north chimney, there is peeling paint due to the improperly ducted boiler chimney. *After Phase I construction, the boiler is scheduled to move to the new addition, this problem will be remedied and this area can be repainted.*

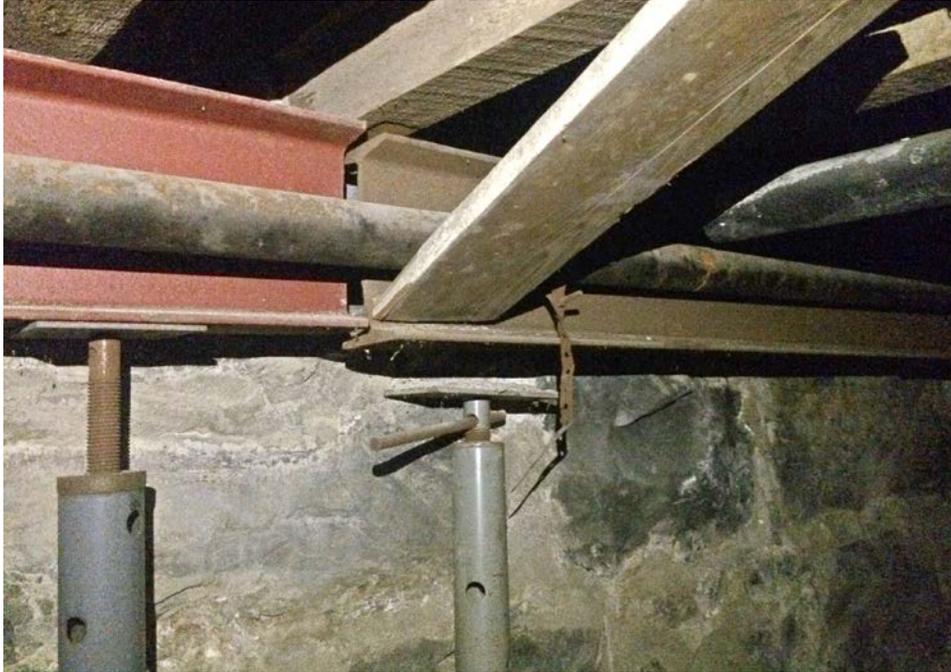
There are rusted and/ or fallen steel columns in the undercroft under the narthex. *In Phase I construction, a structural engineer will evaluate the rusted and missing structural columns under the narthex to determine if there are significant safety issues.*

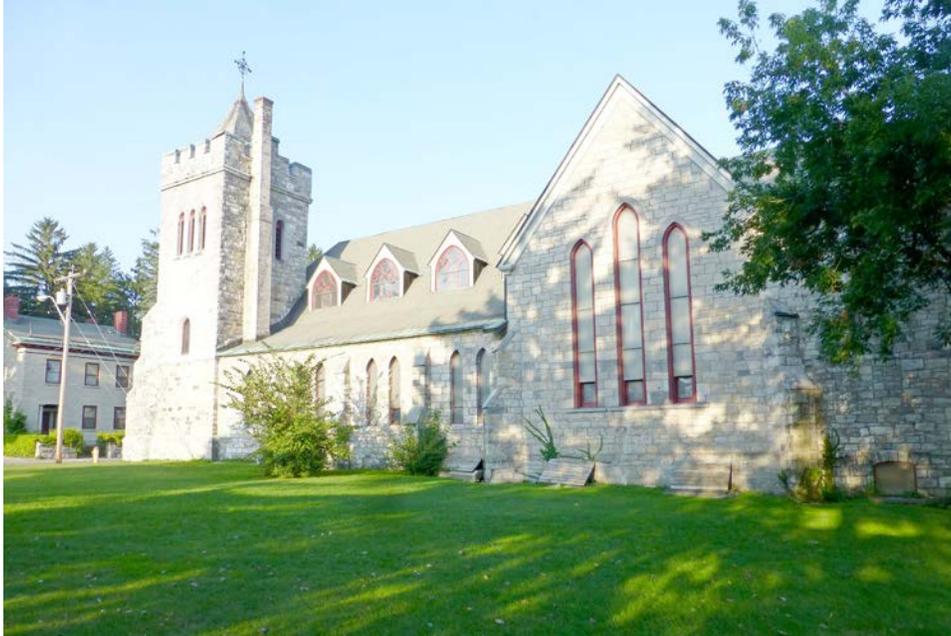
To reduce wintertime ice damming on the church, the roof needs to be insulated. Furring, rigid insulation, and new roofing will be added to the top of the existing roof deck. The new, thicker roof will then sit higher than the sills at the clerestory dormer windows. The sills will then have to be raised and new protective glazing designed.
