BETHESDA ANNUAL MEETING: 2022

PROPERTY MANAGEMENT REPORT

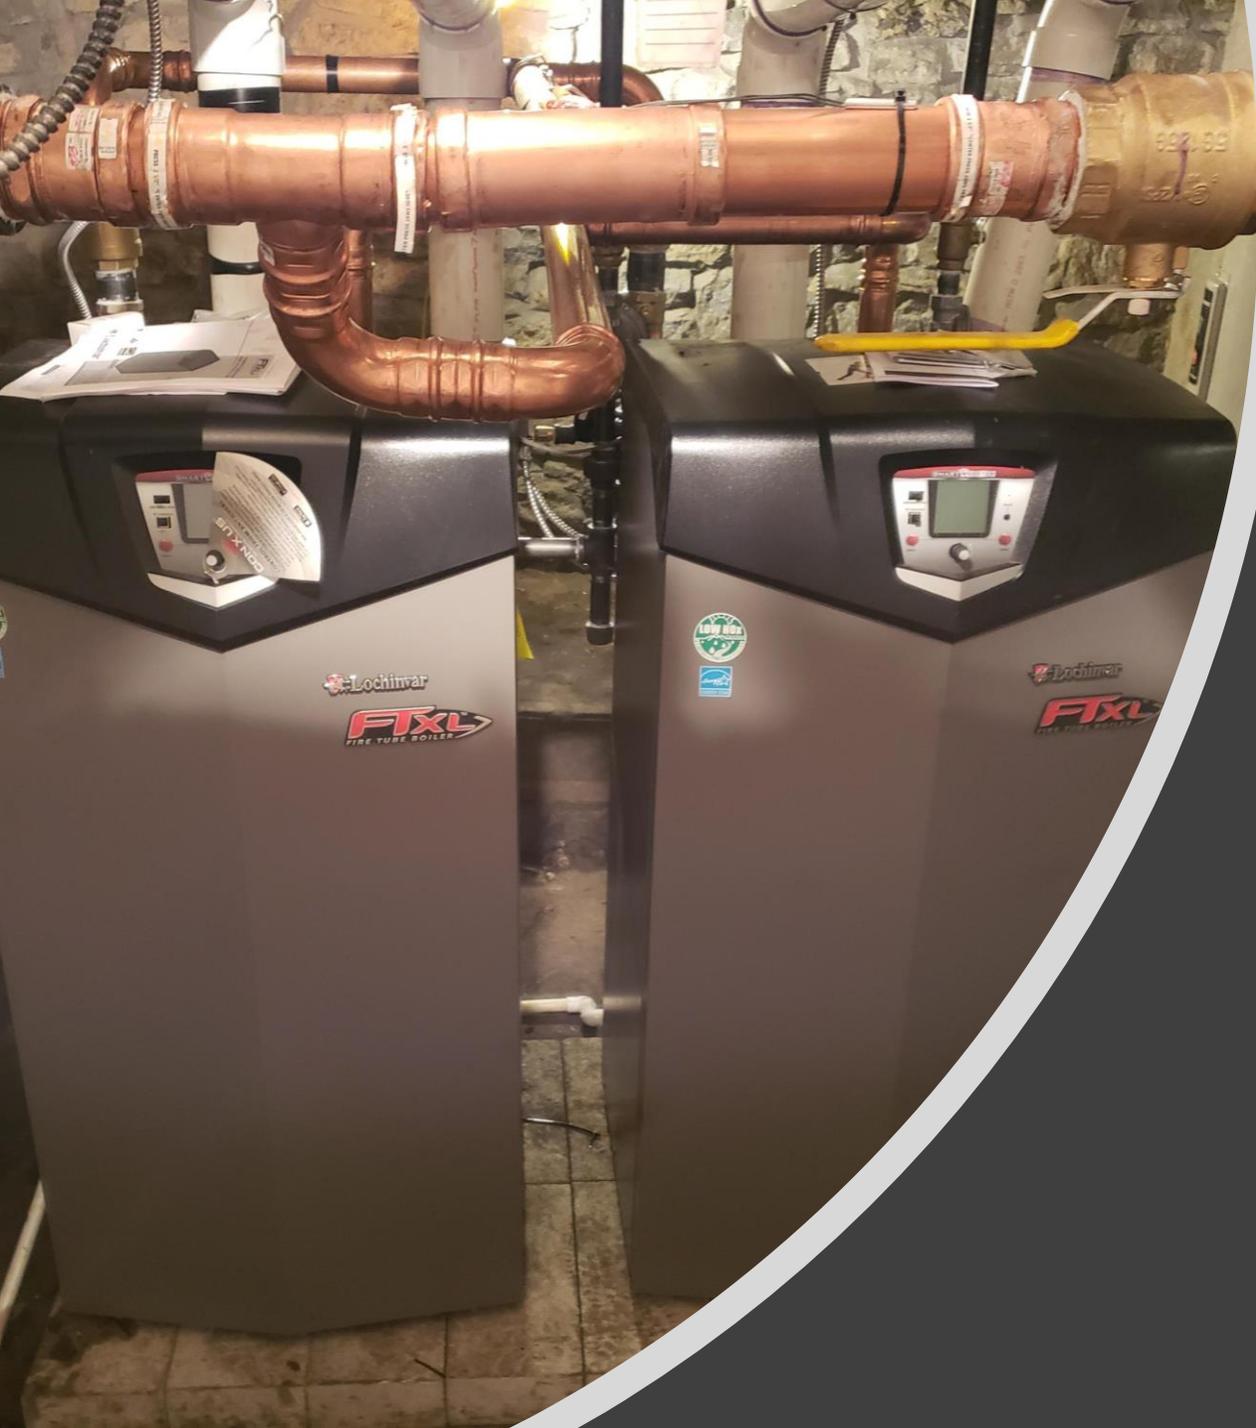
• Boiler Replacement

- In the very late fall, we installed a brand new, state of the art natural gas boiler.

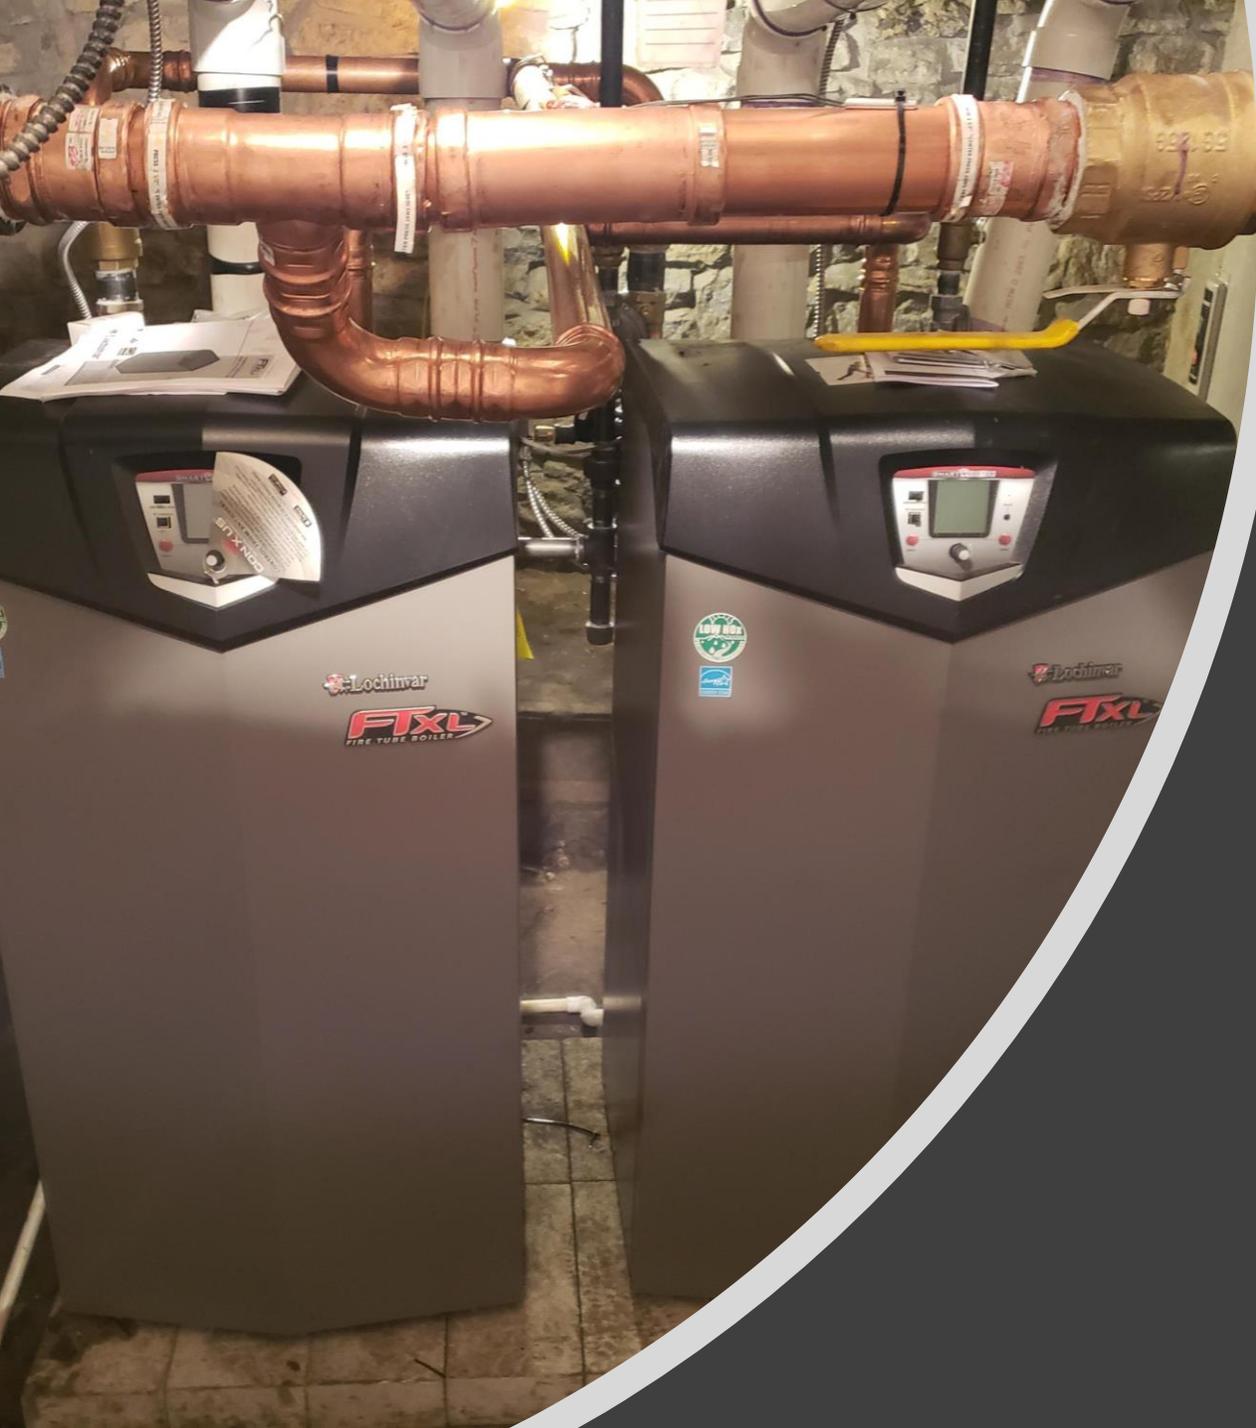
• Boiler Replacement

- In the very late fall, we installed a brand new, state of the art natural gas boiler.

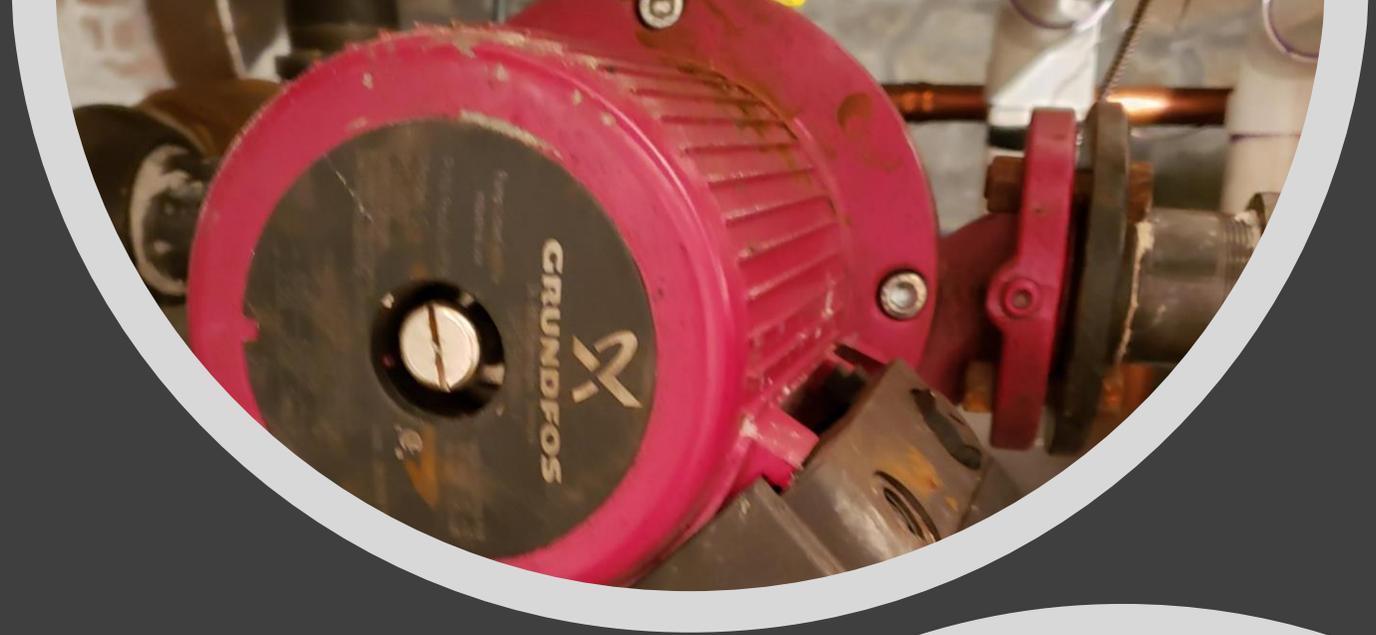
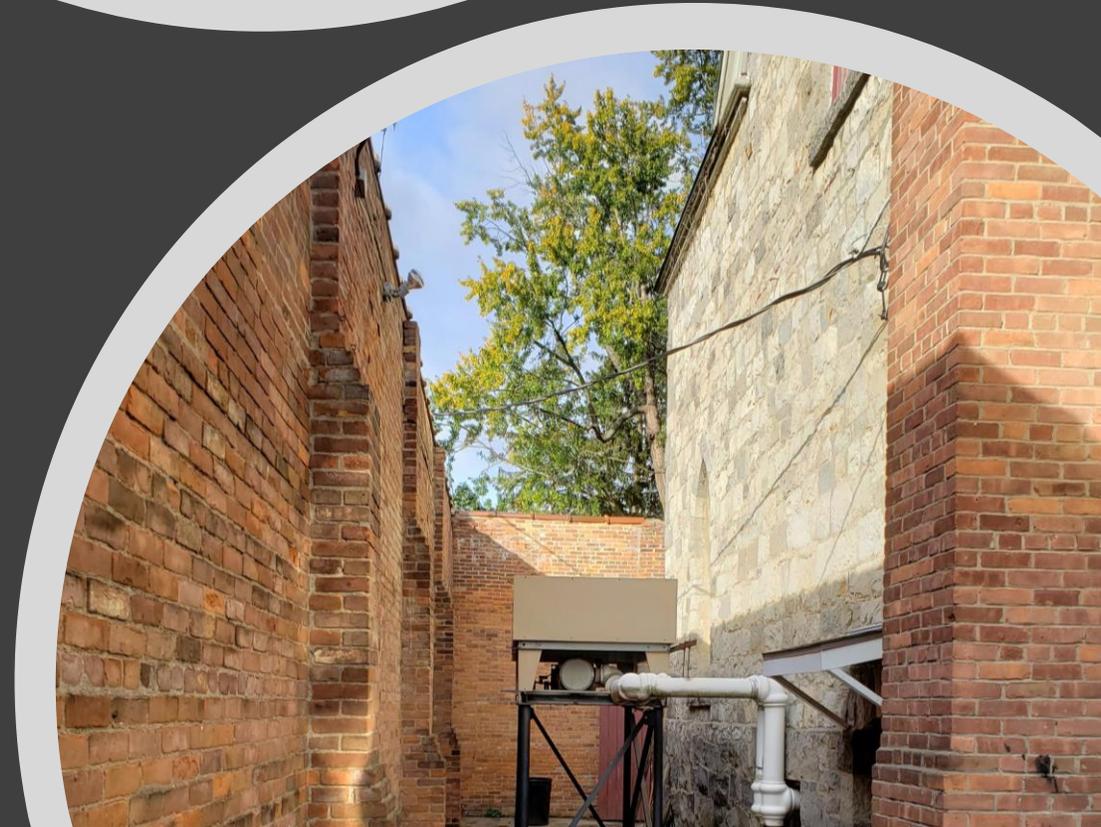
Boiler Replacement

- As you may know Bethesda is heated by circulating hot water (and cooled in the summer by circulating chilled water through the same pipes). Pictured are the hard-working circulator pump in the boiler room and the chiller in the back court yard.

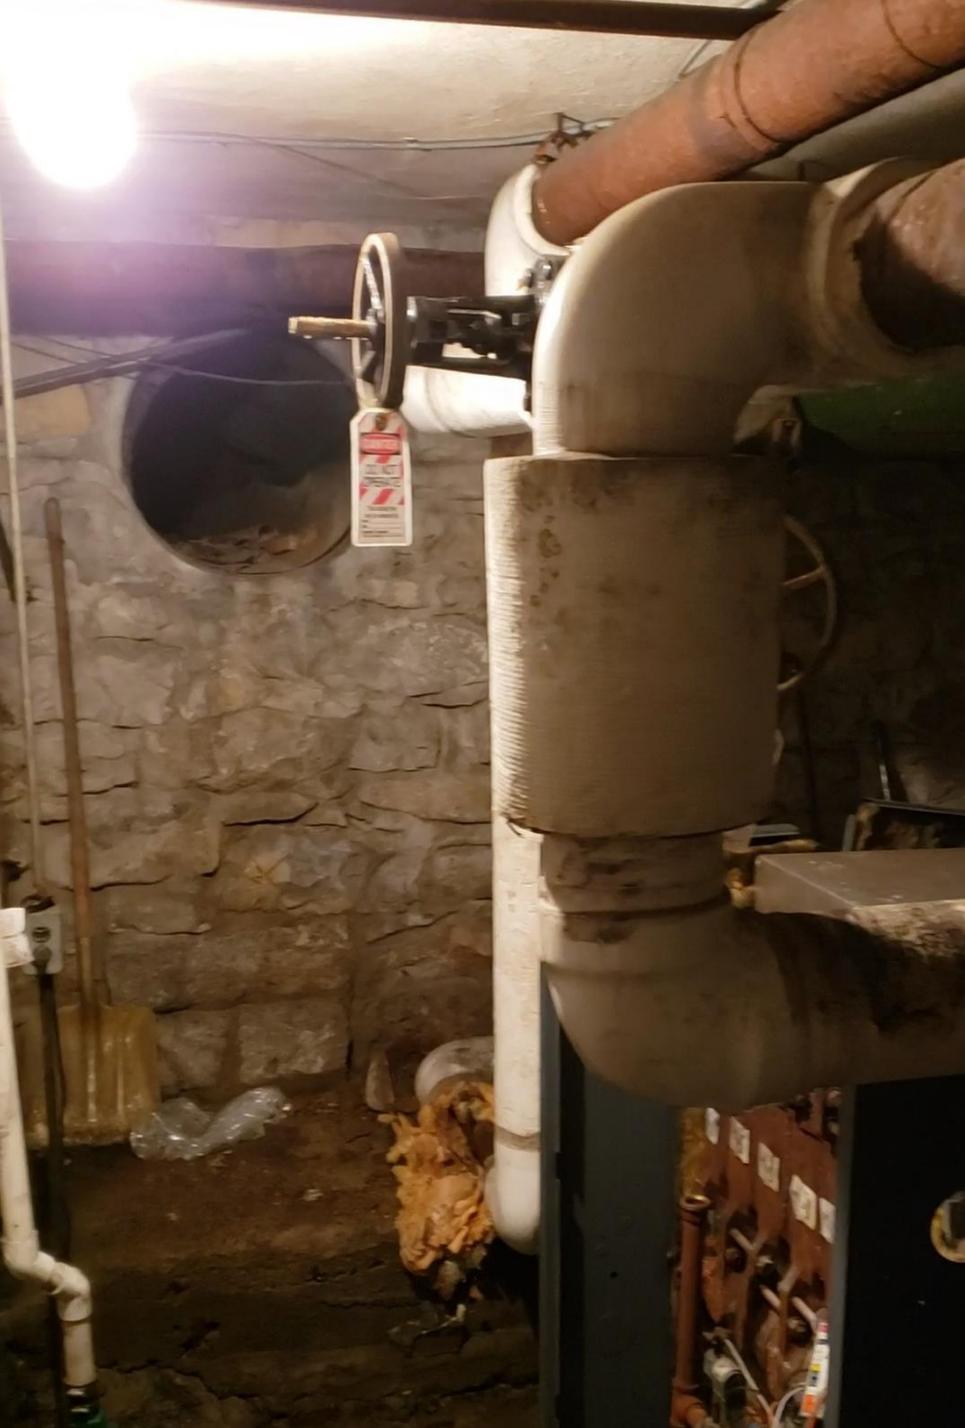
The old boiler had developed serious issues. It was probably undersized for our building and was subjected to excessive stresses.

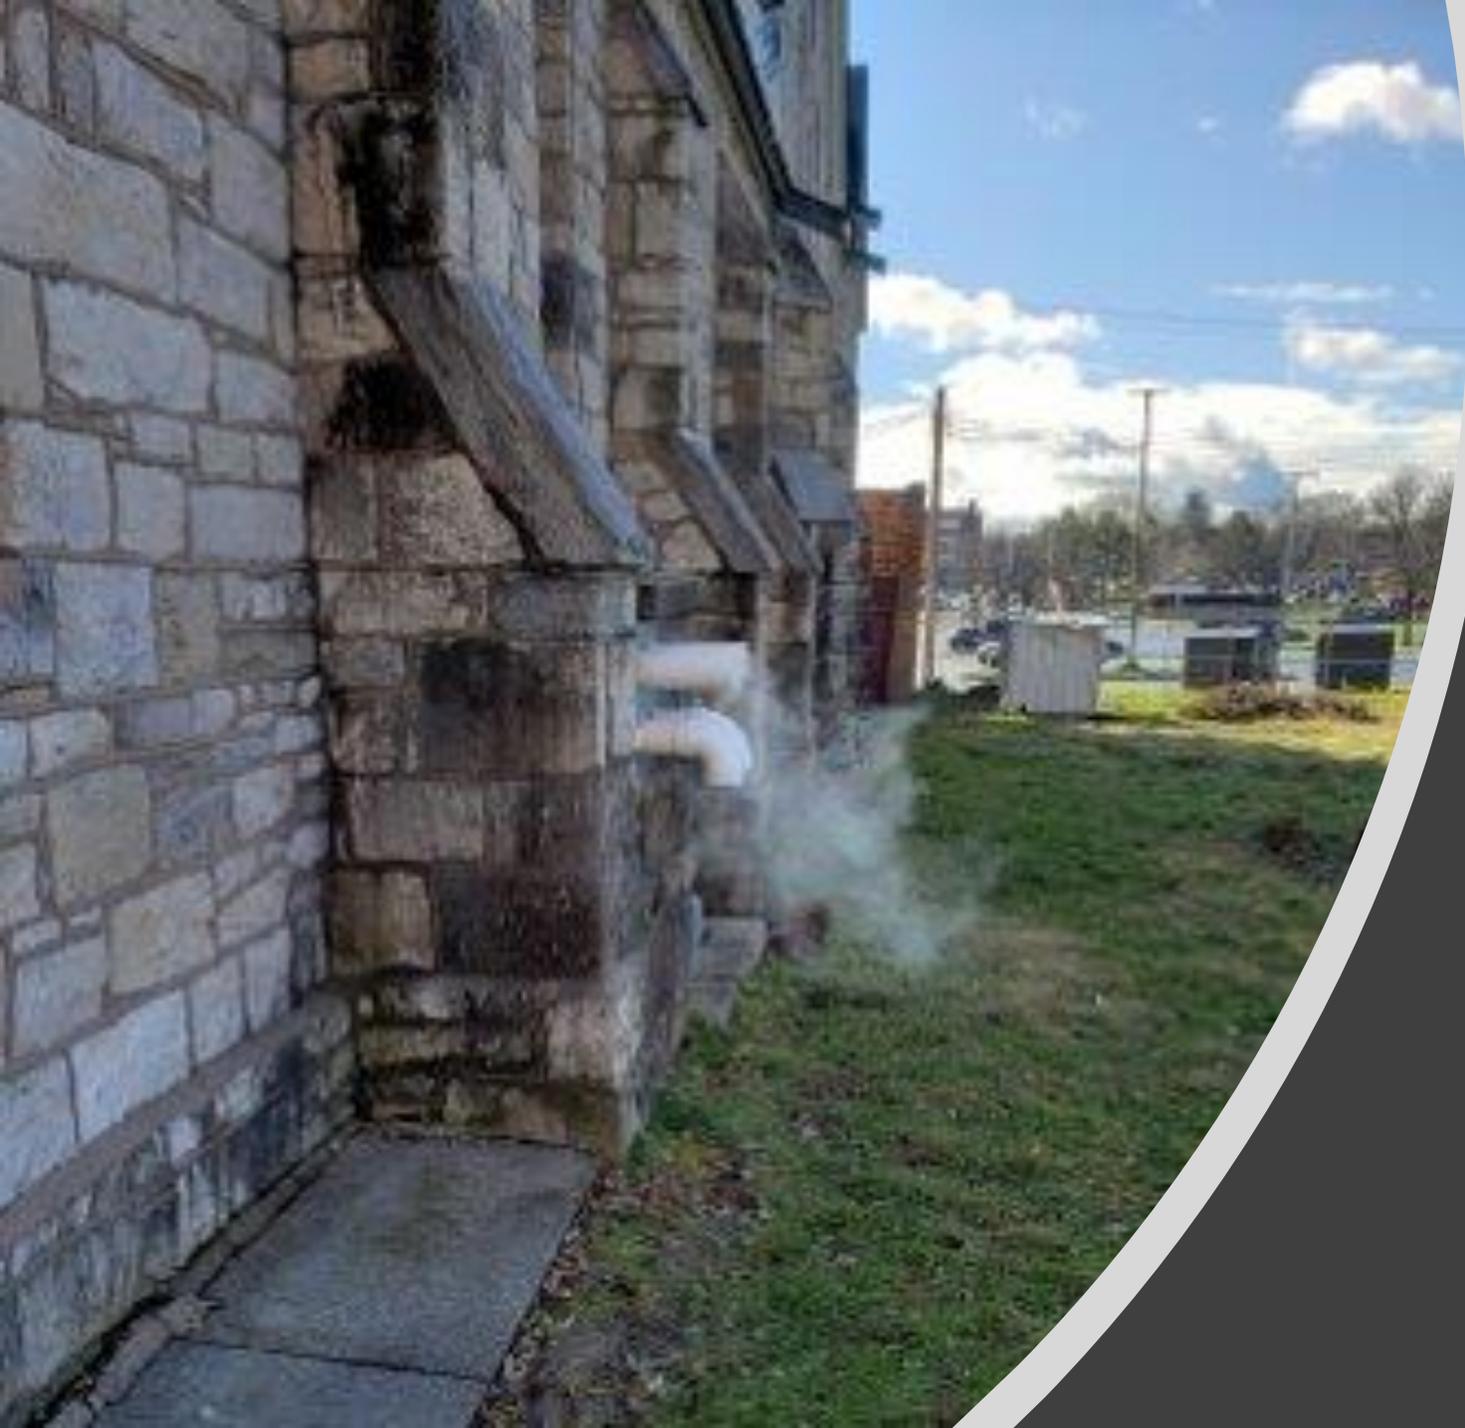
Boiler Replacement

- The new boiler offers significant advantages.
 - It is commercial grade equipment
 - It is highly efficient
 - The double boiler design provides for redundancy – less chance of being without heat, as well as reduced stress on each unit. The two units will automatically alternate.
 - Its display will let us know if it needs service.

No chimney required.

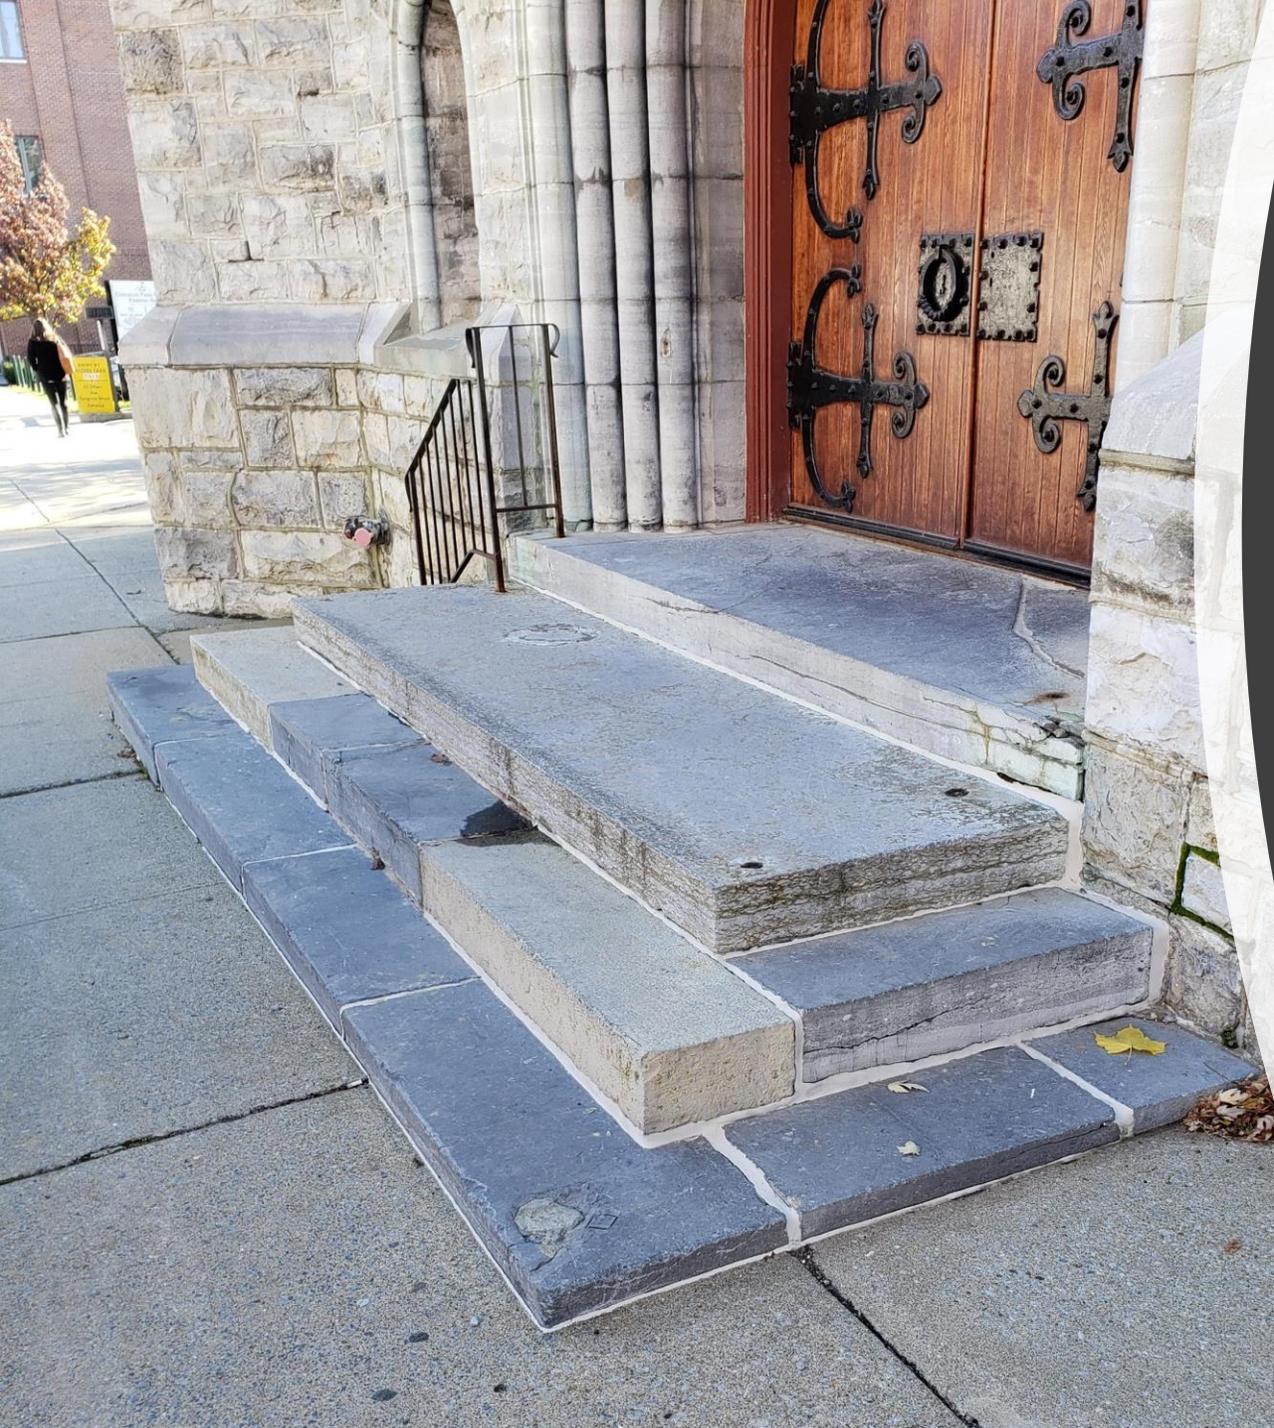
New railings for the front steps

- Two new railings provide support in climbing the front steps. Pictured is the old railing.

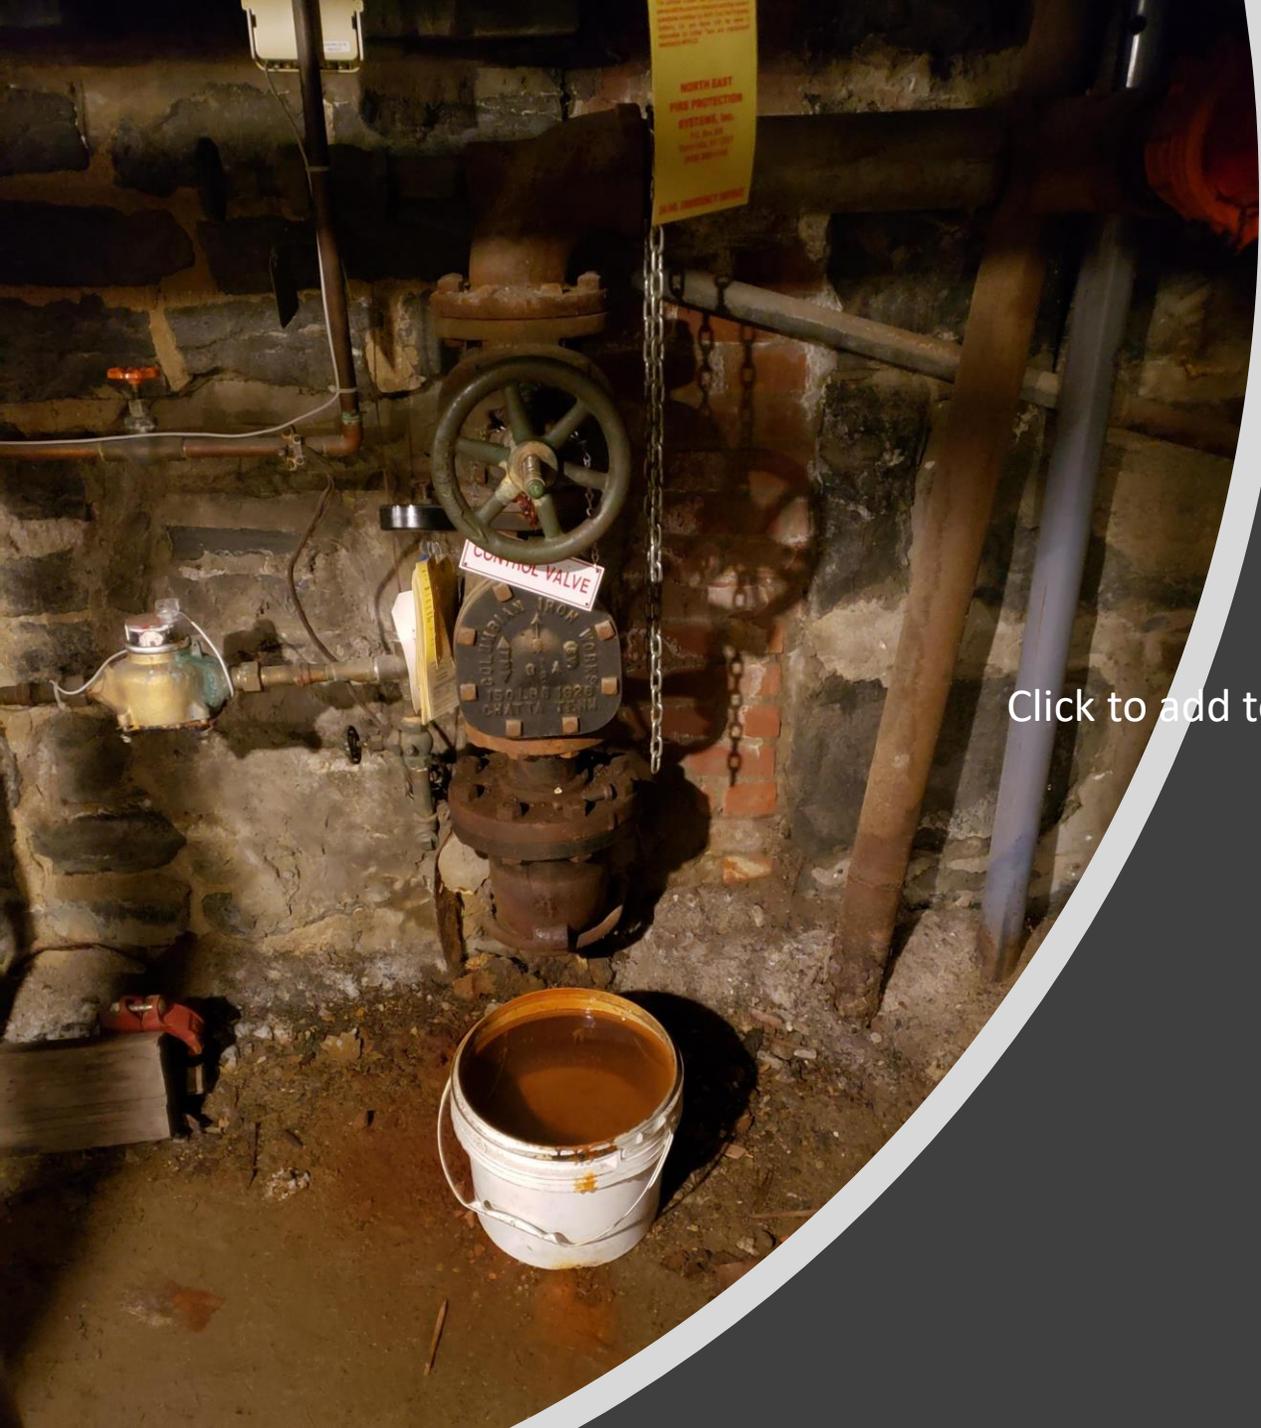
Replacement of Leaking Sprinkler Valve

The valve was so old that parts were no longer available. Because of the leak, it was uncertain whether we had significant pressure in our sprinkler pipes in case of emergency

Replacement of this valve was a significant task, but ensures that we have a working sprinkler system and can pass Saratoga fire inspection.

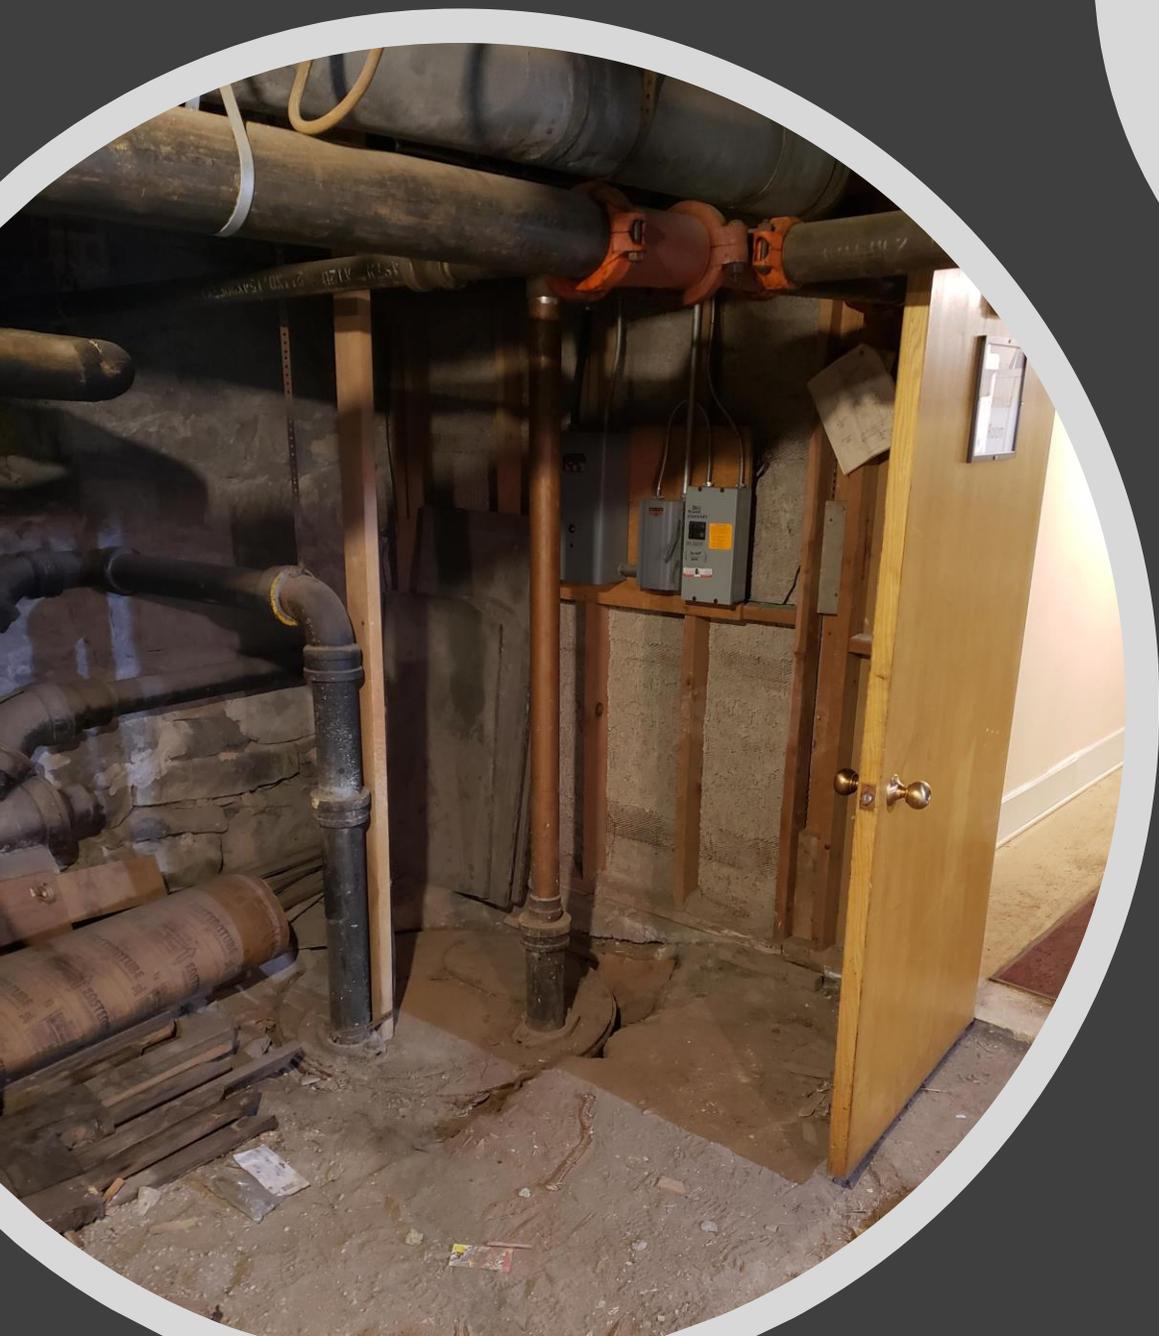
Grinder Pump Replacement

A grinder pump is needed when plumbing is below street level.

- Our pump, which had been grinding away since the 1950s has failed. We are working with Sano Rubin to replace it with equipment of a comparable quality.
- The downstairs bathrooms are closed until the project is complete.
