EXISTING CONDITIONS REPORT

BETHESDA EPISCOPAL CHURCH

SARATOGA SPRINGS, NEW YORK

MARCH 2016

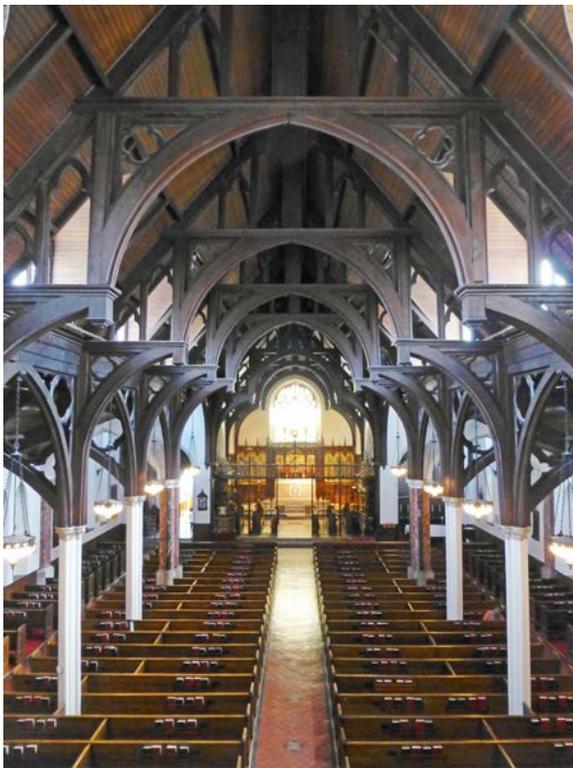
The historic surfaces, designed by Richard Upjohn, remain on the interior of the church. The building fabric is well maintained, but there is evidence of cracked plaster, general paint failure, and moisture damage in various locations throughout the building. The original paint colors and wall decoration have been changed to the present monochromatic decorative scheme, which is not consistent with the original architectural design.
